WARD DAM

NH 00262

PHASE I INSPECTION REPORT
NATIONAL DAM INSPECTION PROGRAM

DECEMBER 1980

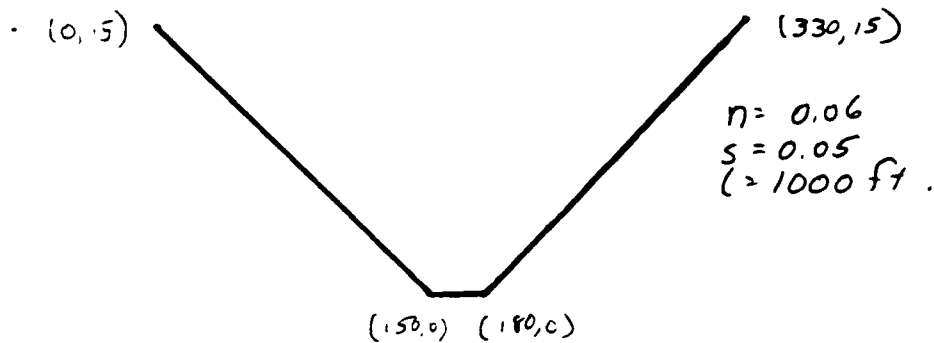
A typical cross-section for Blood Brook just downstream of Ward Dam is as follows:

A stage-normal flow relationship for this reach is given on the next page. The pre-failure flow of 616 cfs would create a stage of slightly under 2 feet in this reach. Dam failure would increase this stage to 4.1 feet at the upstream end of the reach. Assuming a linear variation in stage in the reach, storage = $\frac{\text{storage U/S} + \text{Storage D/S}}{2}$ (length). The attenuation due to storage in this reach is calculated on p. 12.

The attenuated peak dam failure flow at the downstream end of the reach would be 2450 cfs, creating a stage of 3.7 ft. The only development in the first 1000 feet downstream of the dam is one house well above the dam failure flood wave.

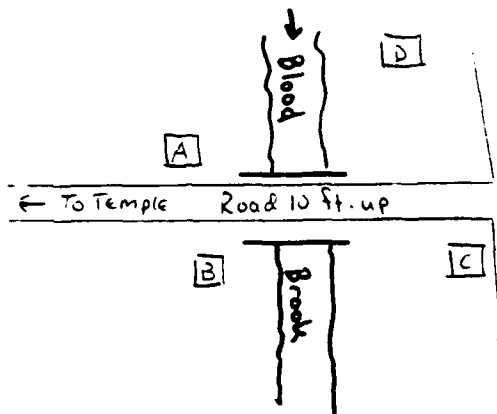
About 1000 feet downstream of Ward Dam, Blood Brook passes under a road leading to Temple, New Hampshire. There are houses downstream and upstream of the bridge as shown in the sketch below:

House	Description
A	Cellar 4 feet above stream. 1st floor at roadway level (10 ft. above stream).
B	1st floor 2-3 ft. below roadway level.
C	1st floor at roadway level.
D	Well above stream.

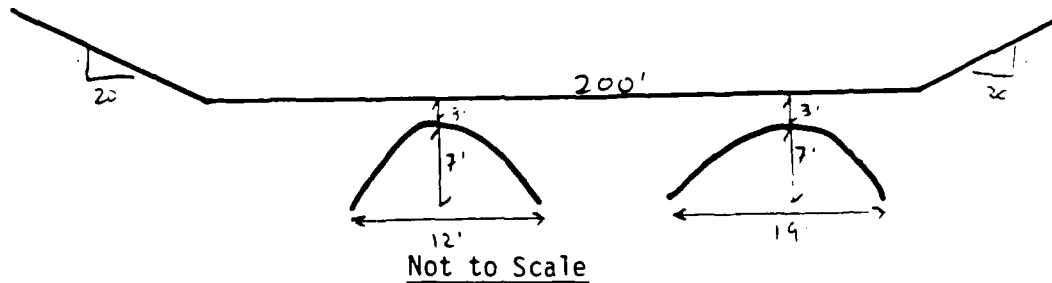
The bridge on which the road to Temple crosses the brook would control flow in this area. A sketch is shown below:

The storage immediately upstream of this bridge is negligible, so that little attenuation of peak dam failure flows would occur here.

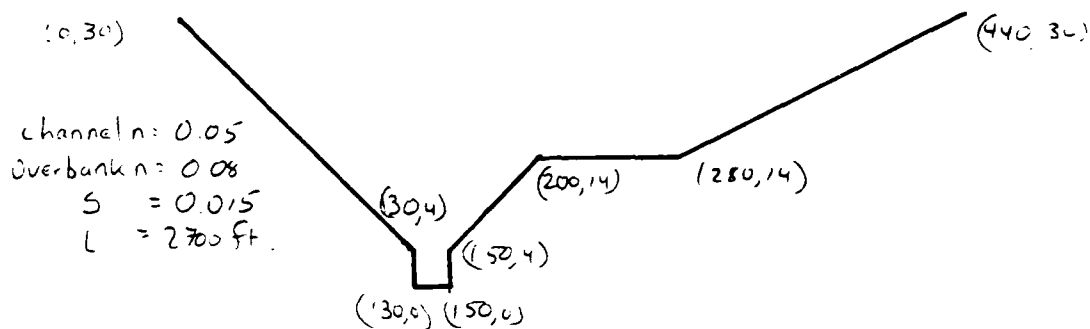
About 700 feet downstream of this bridge, Blood Brook is joined by Temple Brook. There is one house in this reach (besides the two already discussed), about 8-10 feet above the stream channel. Blood Brook runs 2000 feet from the conjunction with Temple Brook to a restaurant and a house at the downstream end of West Wilton. In this reach there are 3 houses 10-15 feet above the stream channel, and the restaurant and house 12 feet up. The following cross-section is typical of the reach from the bridge to the downstream end of West Wilton:

A stage-normal discharge relationship for this reach is given on the next page. The pre-failure flow of 616 cfs would cause a stage of 4.1 feet in Blood Brook. The peak dam failure flow of 2450 cfs would cause a stage of 8.4 feet at the upstream end of the reach. This would attenuate significantly through West Wilton due to the storage provided by the stream. The only structure which might receive minor (less than 0.5 feet) flooding in this reach is the lowest house.
